Manhole Inspection Summary

Manhole # S23K__020MH

Insp Date: **6/10/08 10:22 AM**

Location Address: **301 S Gilmore St**

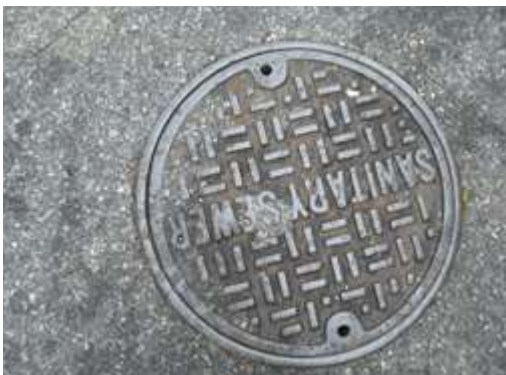
Cover View

Condition: **Sound**

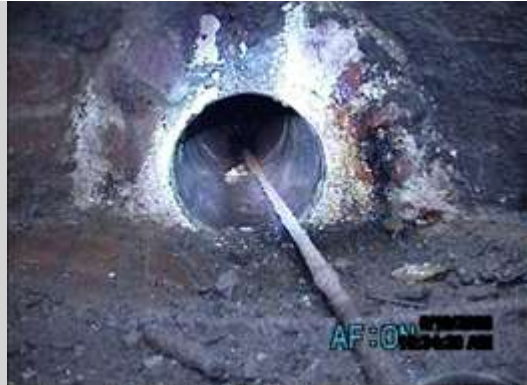
12 O'Clock Outflow

8 in. Circular Gravity Sewer
Pipe Out @ 12 O'Clock

Pipe Height: **8.4** (in.) Rod and Bar (Angled)

Pipe Material: **Clay** ☐ Pipe Lined

Infiltration: **None** Pipe Seal Cond: **Sound**
